Teakdeckrenovation Vagabond 47

The situation before the start of work

Shipbuilding 1981

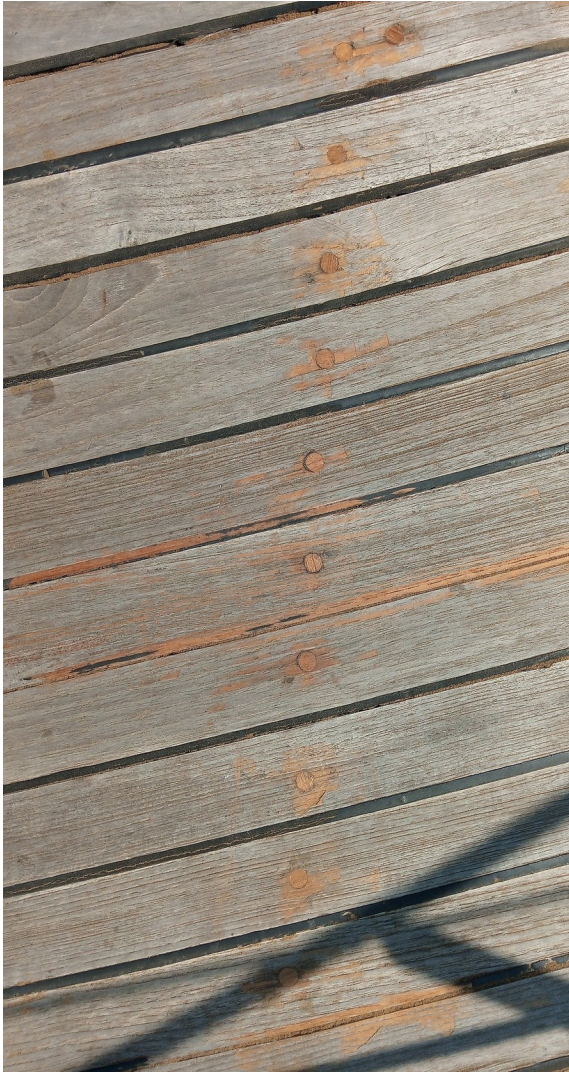
A measurement showed that the deck should still be 10 mm thick. Now afterwards it was clear that some parts were ground down to 7 mm.

The screws or the epoxy over the screws were exposed to a good half.

The strips that were glued to the right wood side had mostly bent up on the sides and "formed a channel" in the middle. The adhesion of the planks to the gelcoat was largely gone.

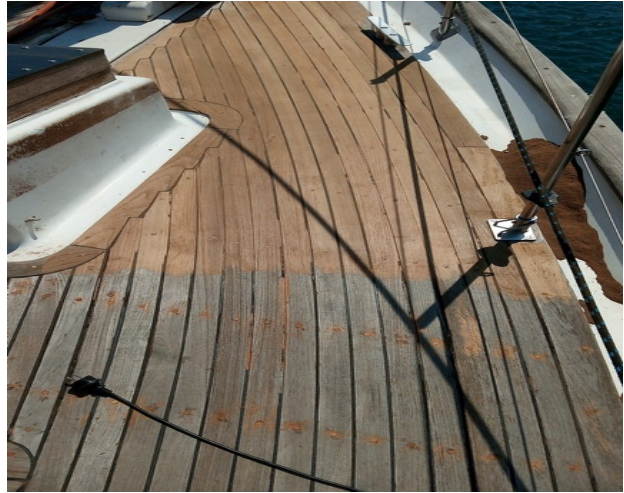
The casting compound had come loose on some "side edges" of the joints and was brittle in some places. The joints were often only <math><1\text{mm}</math> deep.

It was obvious that all screws (1830) would have to be set deeper. Then the deck should be sanded smooth so that the joints could be milled again with a router. (Only through trials could a method be found to rework the joints) It was also clear that the grouting was only possible with the help of a compressor, since a total of approx. 450 m of joints and 36 m² of teak deck were measured.

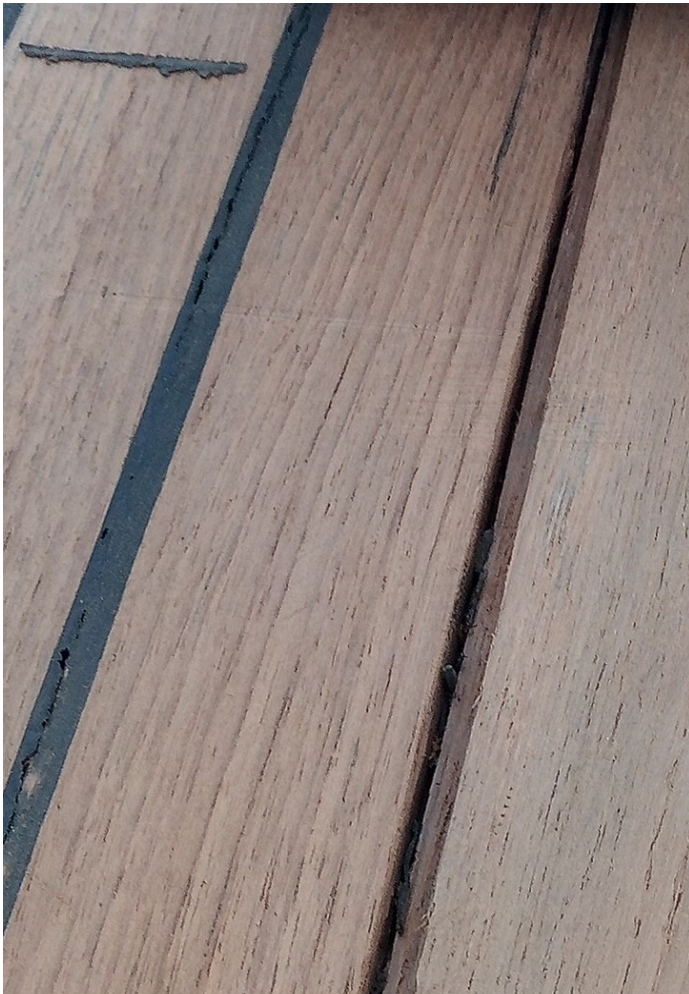
One problem was that the former joint width of 4mm was hardly noticeable over the length of the joints.

Once it was only 3mm then up to 7mm. I suspect that this already happened when the boards were laid in 1981 and that the planks were simply not laid exactly 1mm apart next to each other.

There was nothing left but to mill many joints several times or to take out the remaining old joint compound with the Vevor "free-hand milling machine".

The flanks were then freed from the remains of old joint compound with the multitool and the "rasp blade".

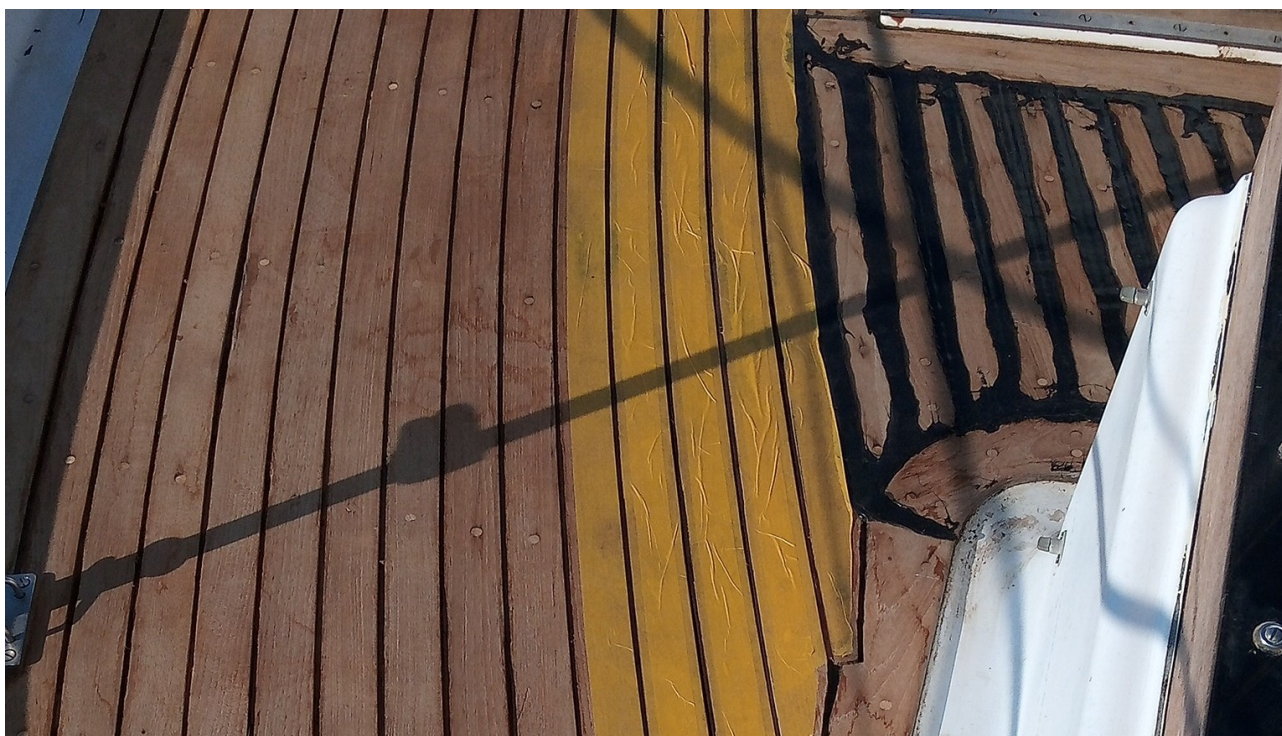
A few areas that could not be sanded completely due to a suspected lack of material were masked off. Holes and other damaged areas are either sealed with teak plugs or cast with epoxy.

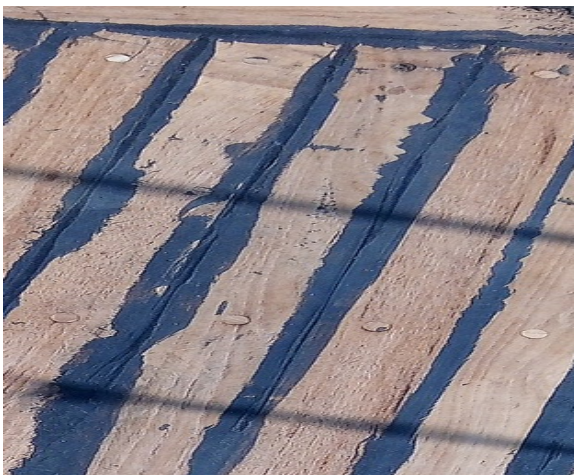
Picture above: Pressing is only possible with a narrow spatula, unfortunately the overhang is considerable.

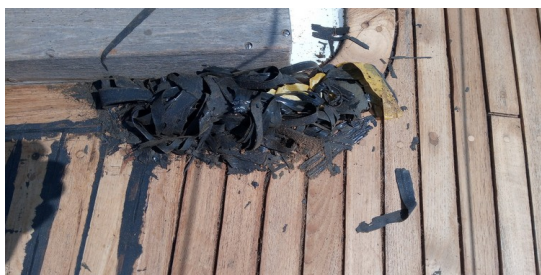
Picture aside: Possibly too little joint compound was used here. Unfortunately, you can only see this exactly after it has been sanded.

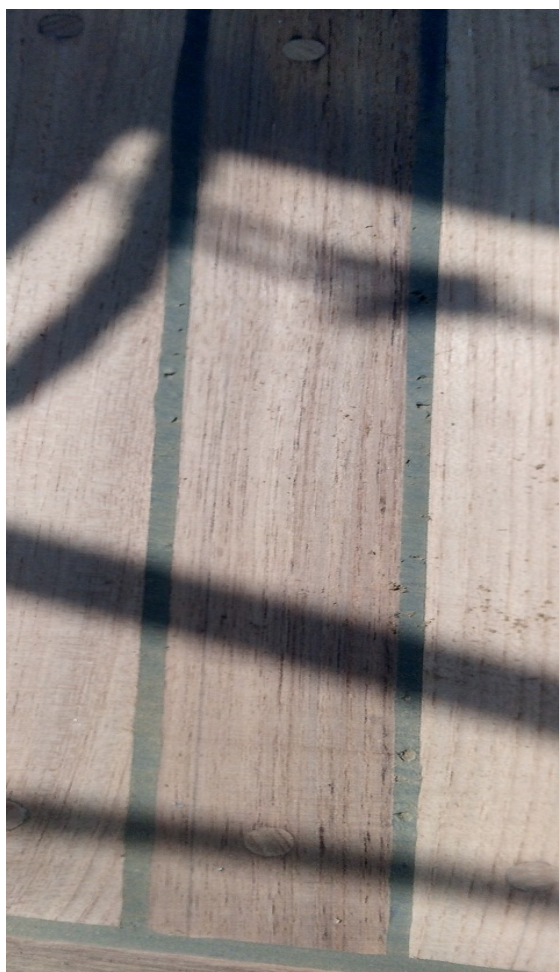
The "joining" or grouting again in the event of errors - there were about 10m that had to be redone because the joint compound bubbled or did not bond on the side surfaces - proved to be problem-free. The beginnings were no longer visible.

After that I waited sixty hours before using the oscillator and the cutting knife to cut away the excess at the joints. Joint scrapers or the kitchen scrapers for the electric stove proved to be much too tedious. The oscillator worked fine.
