Teakdeckrenovation Vagabond 47

The situation before the start of work

Shipbuilding 1981

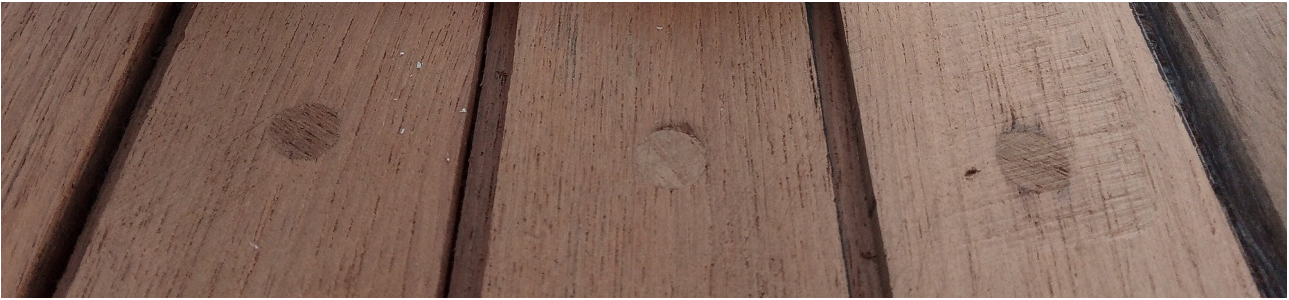
After the first "stop joints" had been carefully milled (a slight correction was possible by lifting the block), I doubled the support of the Bosch milling machine so that the stop sanded with the Flex had a depth of 5mm and knocking on the left and right of the joint was possible. That went quite well for most joints. Nevertheless, it is extremely tedious because you have to constantly check whether the milling machine is actually running within the old joint.

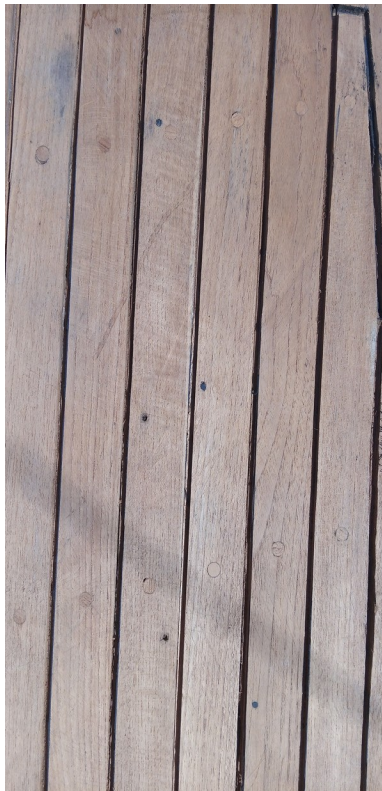
It was not possible to find the 5mm milling cutter for the Dremel and which is reasonably stable (after 40 cm the 4.7mm milling cutter from Proxxon and Dremel was already closing time) I ordered a small router. There were no annoying handles and the support plate had a diameter of just 90 mm. However, I could not find a milling machine where the stop was not obviously designed in kindergarten. So I was allowed to mill everything freehand with this milling machine because of the incompetence of the manufacturers. That was of course tedious and also very slow. It still worked halfway though.

One problem was that the former joint width of 4mm was hardly noticeable over the length of the joints.

Once it was only 3mm then up to 7mm. I suspect that this already happened when the boards were laid in 1981 and that the planks were simply not laid exactly 1mm apart next to each other.

There was nothing left but to mill many joints several times or to take out the remaining old joint compound with the Vevor "free-hand milling machine".

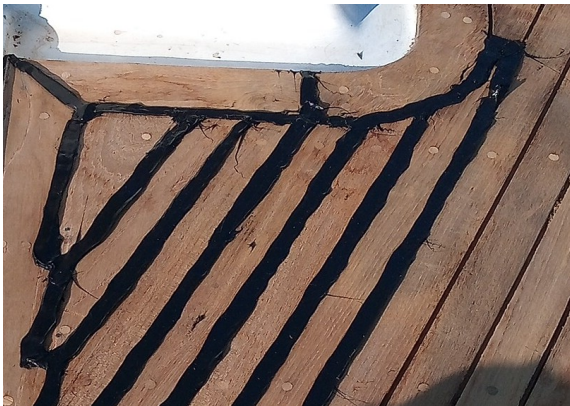
Before grouting, the deck was of course swept several times and the joints were vacuumed. Just before grouting, isopropanol was applied to the joints with a brush. Due to the high temperature, the alcohol evaporated after about ten minutes. After about twenty minutes it was grouted.

I always cut open four cartridges and put them in the sun so that they become even more liquid. I then always grouted two cartridges and then pressed the grout with a narrow spatula (3 cm wide) to just those approx. 2 mm (rather 3-4 mm) flat.

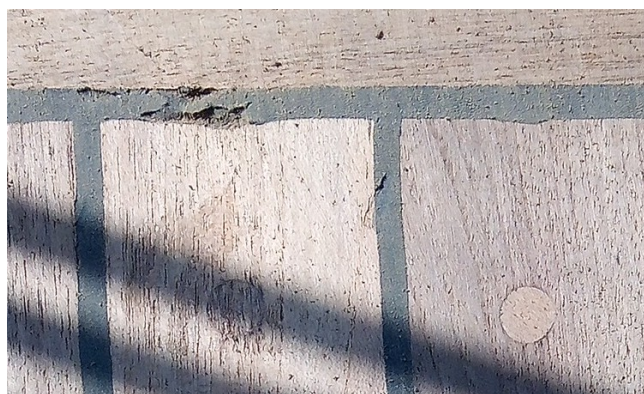
The "joining" or grouting again in the event of errors - there were about 10m that had to be redone because the joint compound bubbled or did not bond on the side surfaces - proved to be problem-free. The beginnings were no longer visible.

After cutting and ultimately throwing away a good 25 kilos of joint compound, I sanded away the remaining protruding joint compound again with the belt sander with 40 grit and then sanded the entire deck again with 120 grit.

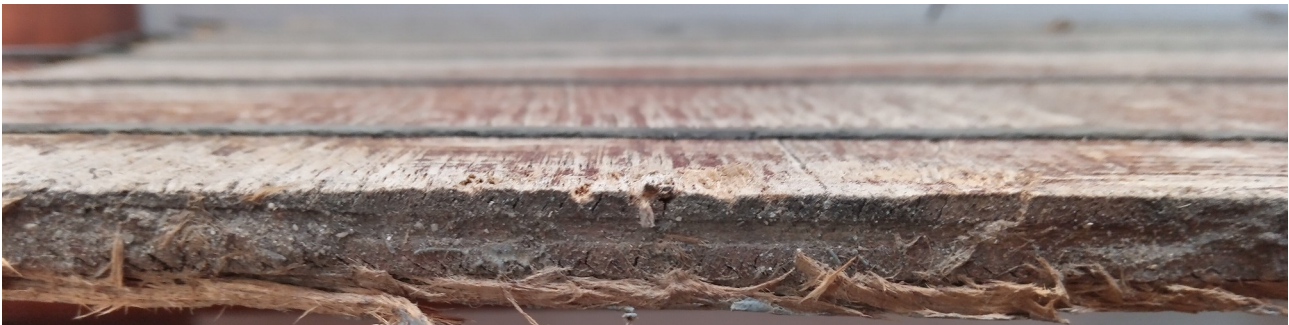
Furthermore, I accidentally found a piece of a new old teak deck plate. The material was 8mm thick, but only 2mm is teak and the rest is cross-glued plywood. The joints milled into the panel are just 1 mm deep. So grinding this material was bound to fail. I give this teak deck a maximum of ten years and I bet that the cost of a teak deck of this type is at least 15,000 euros. And it can't be worth it.
